Manhole Inspection Summary

Manhole # S41MM_001MH

Location Address: **2027 HOLY CROSS LN**

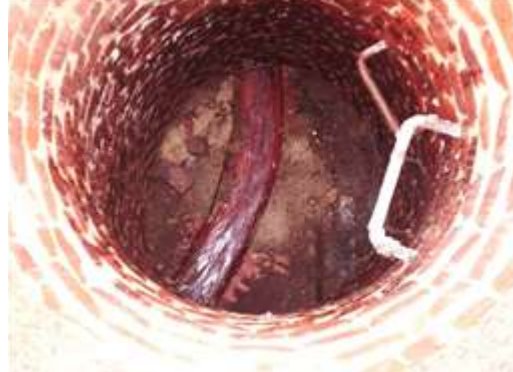
Top View

Bench ☒ Exists Material: **Brick** ☐ Parged ☒ **Debris** (not Condition related)

Steps Count: **4** Missing: **0** ☒ **Corroded**

Surcharge ☒ **Evidence Of Surcharge** Depth: **1** (ft.) ☐ Active Surcharge Present

Corroded steps. Evidence of surcharge - Bench debris.

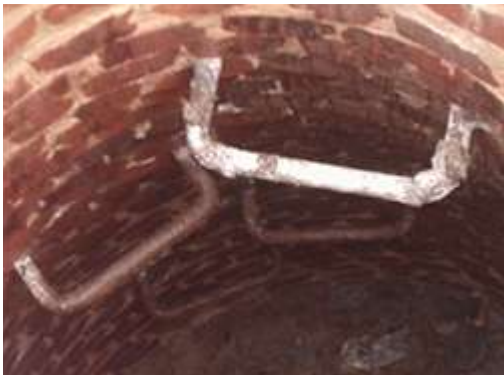
Defect

Infiltration: ☐ None ☐ Joint ☐ Cracks ☐ Mortar ☐ Roots ☒ **Wall**

Corbel infiltration.

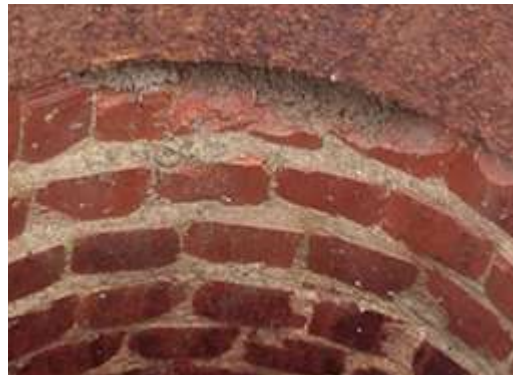
Defect

Condition: ☐ Sound ☐ Cracked ☐ Root Intrusion ☐ Loose Brick ☒ **Deteriorated**

Infiltration: ☐ None ☒ **Joint** ☐ Cracks ☐ Mortar ☐ Roots ☒ **Wall**

Adjustment deterioration and infiltration.

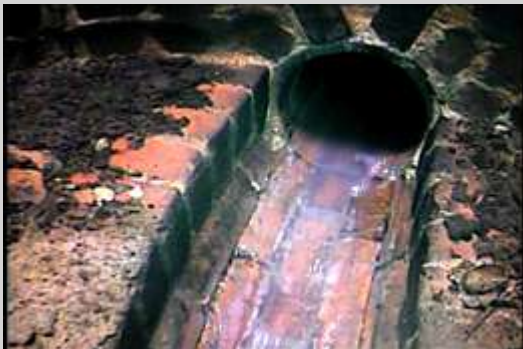
8 in. Circular Gravity Sewer Pipe In @ 7 O'Clock

Condition: ☐ Sound ☐ Cracked ☐ Root Intrusion ☒ **Deteriorated** ☐ Leaks ☐ Debris

Channel deterioration.

Infiltration: **Evidence** Pipe Seal Cond: **Unknown**
